High Speed Data Acquisition Examples

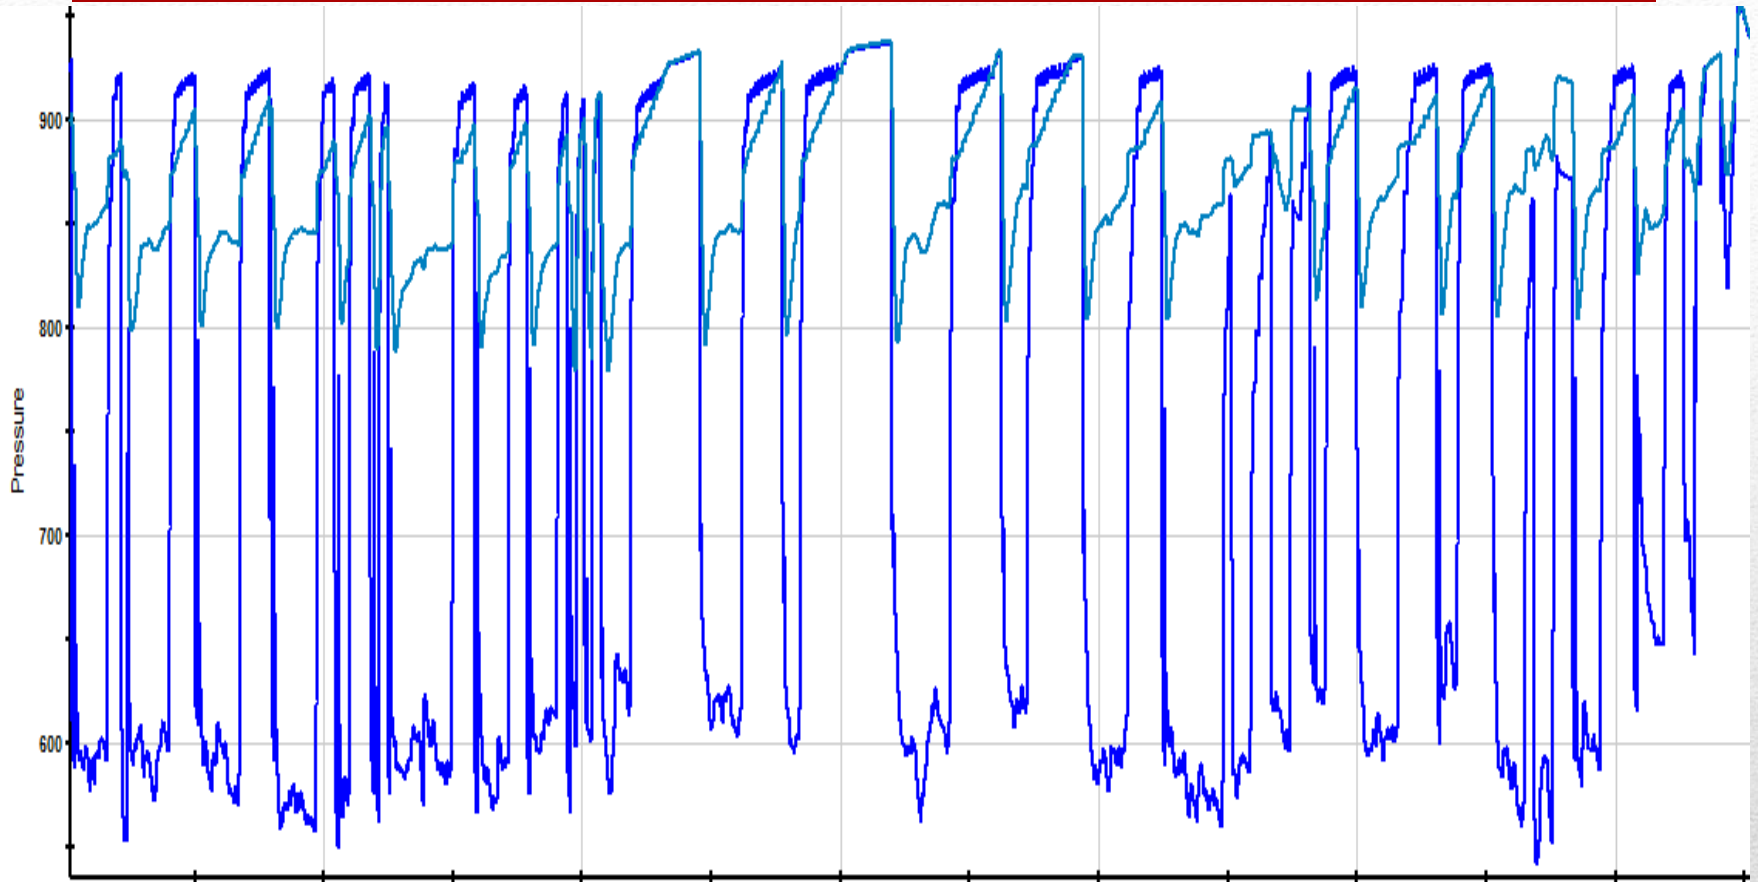
Leaky standing valve on plunger well

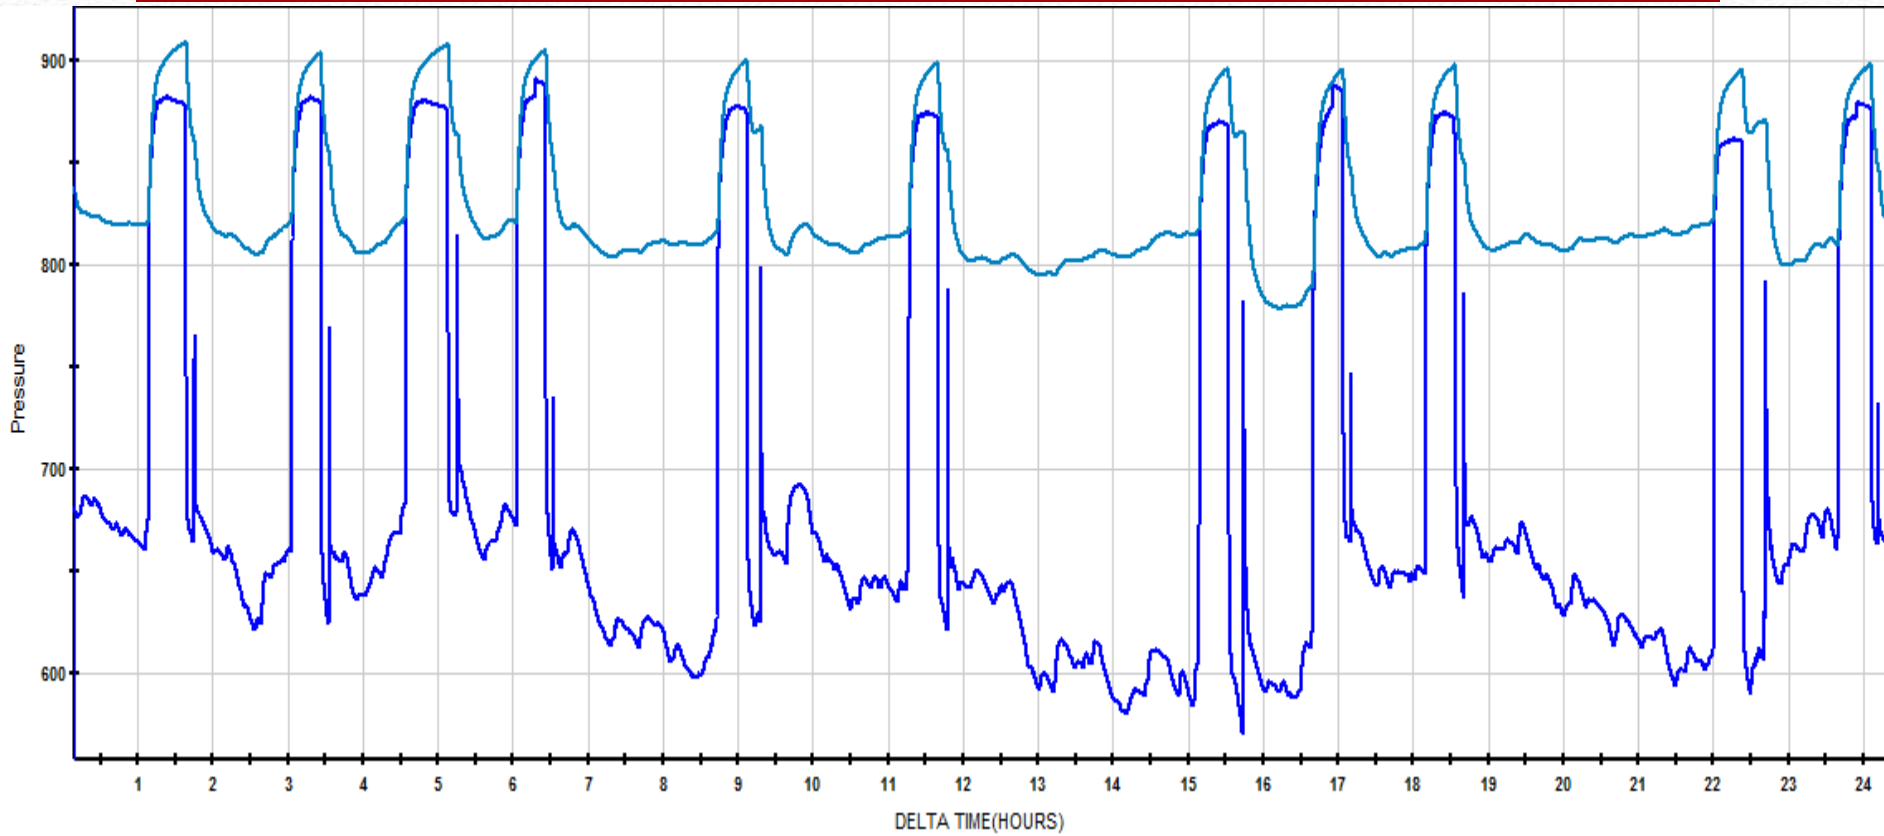
**Same well after standing
vale repair**

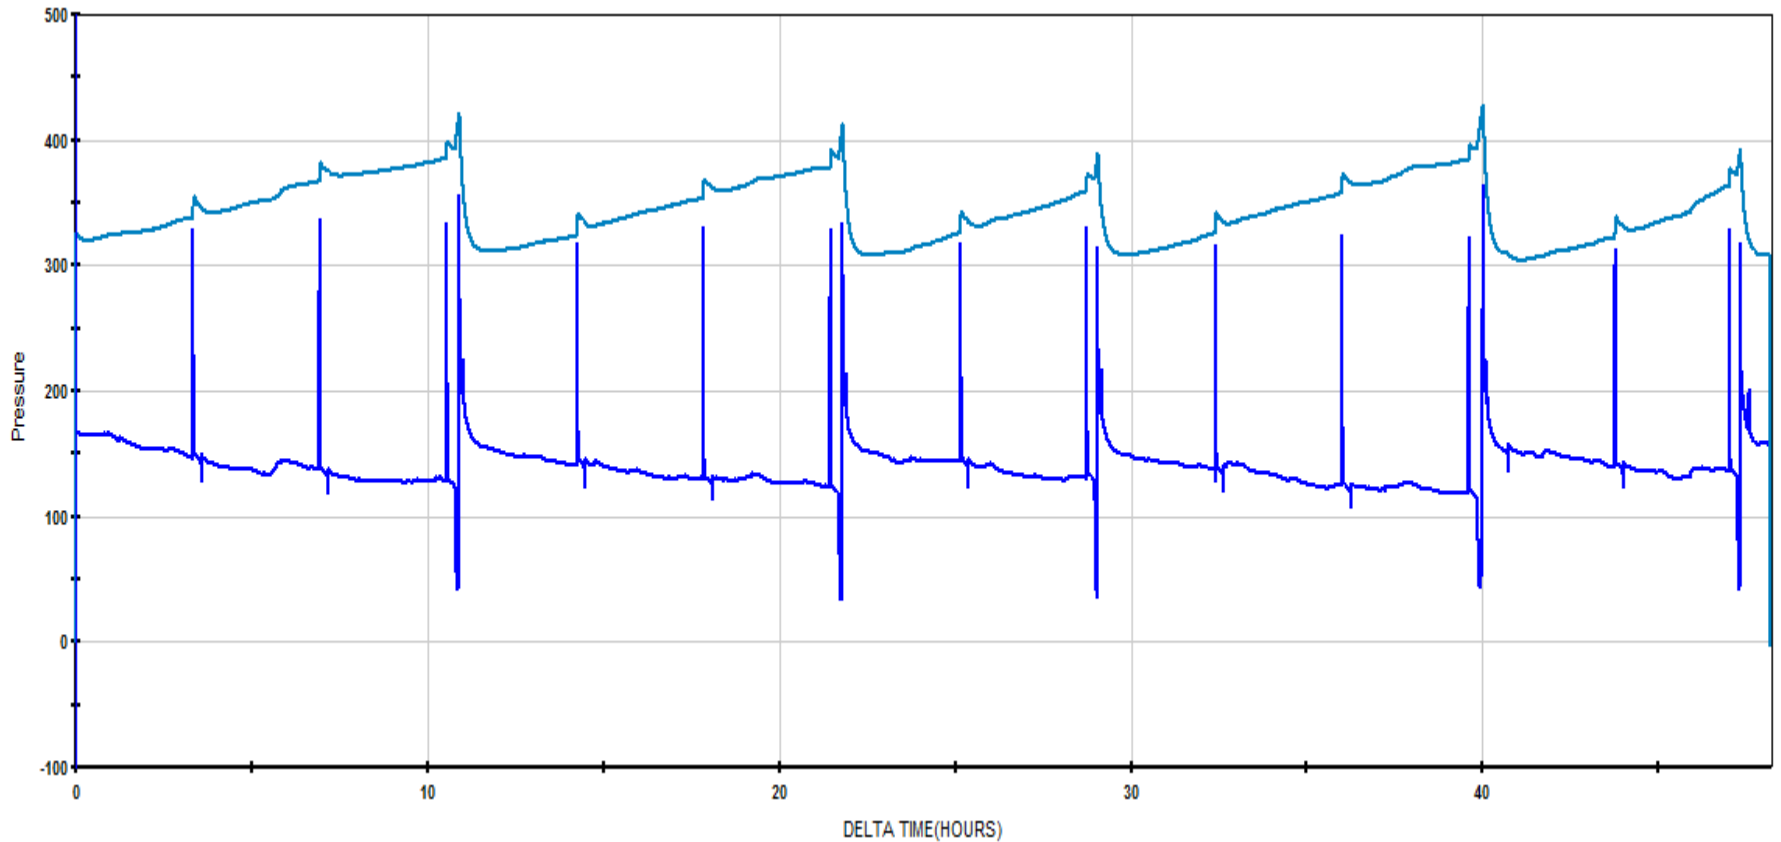
**Bypass plunger not
getting to bottom**

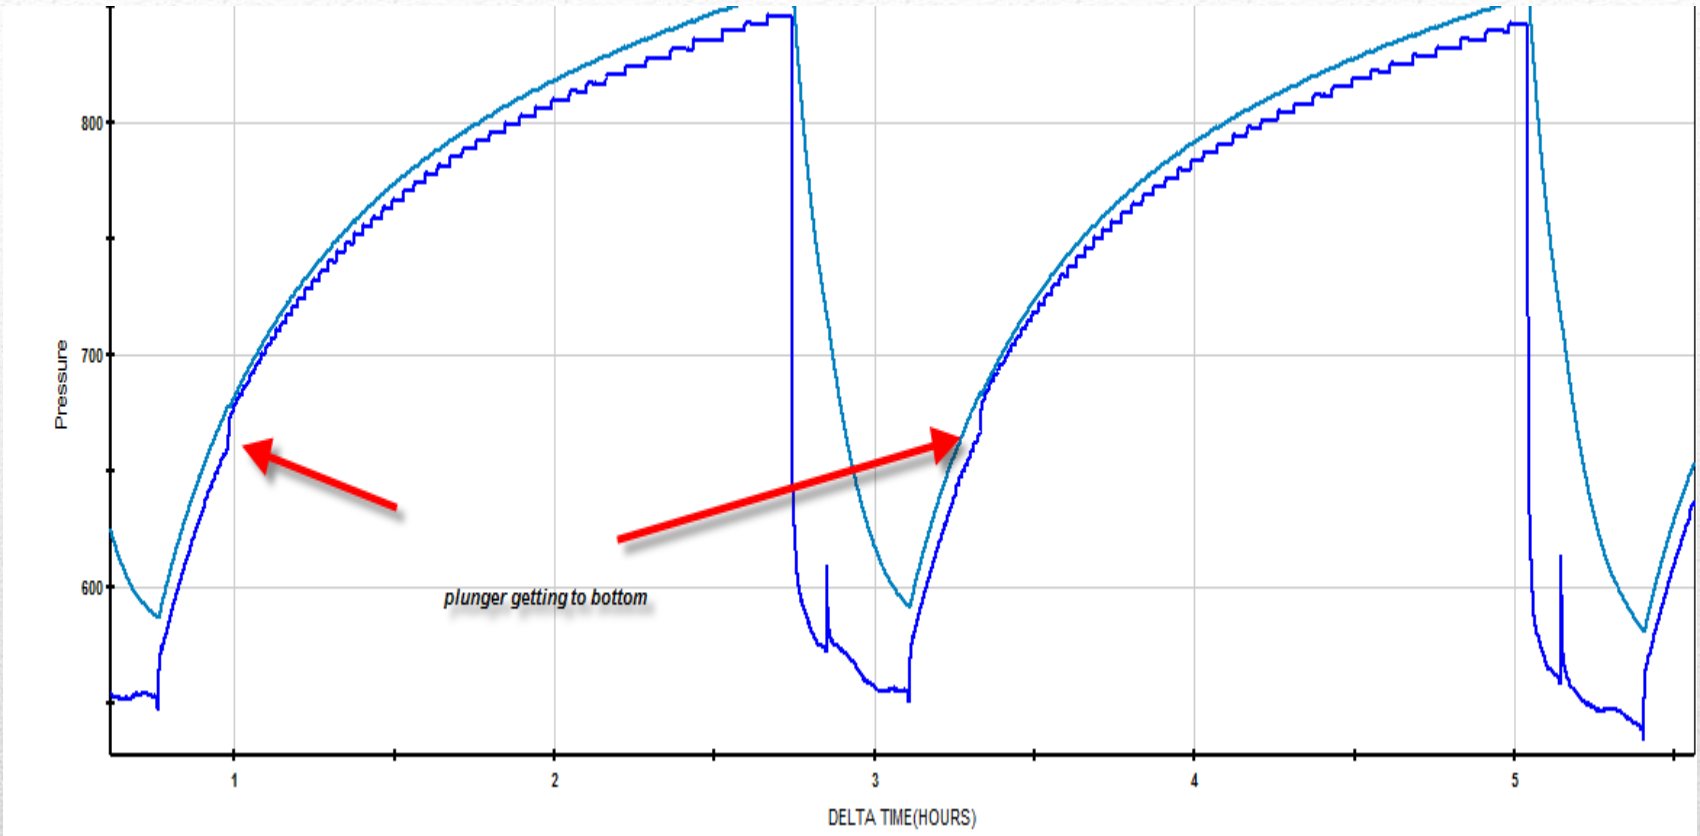
Plunger getting to bottom
